Property Inspection Report

54 Smart Street

Abbotsville

INSPECTION OF 54 Smart Street Abbotsville

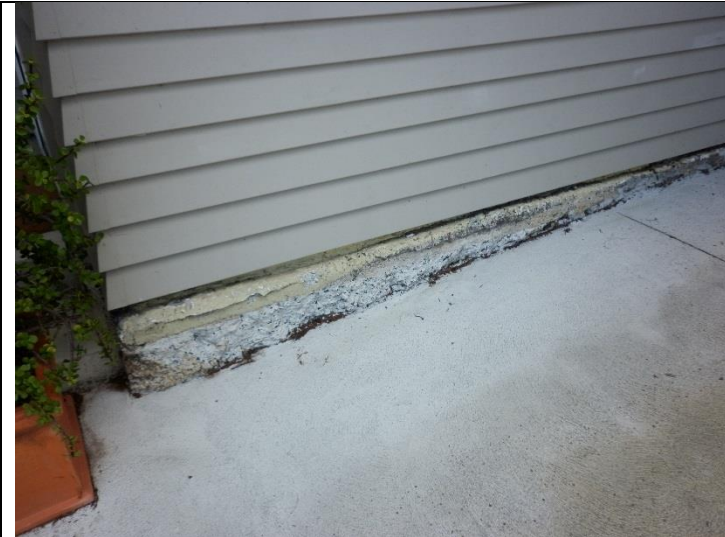
Weatherboards on a cavity with exposed footing shown below.

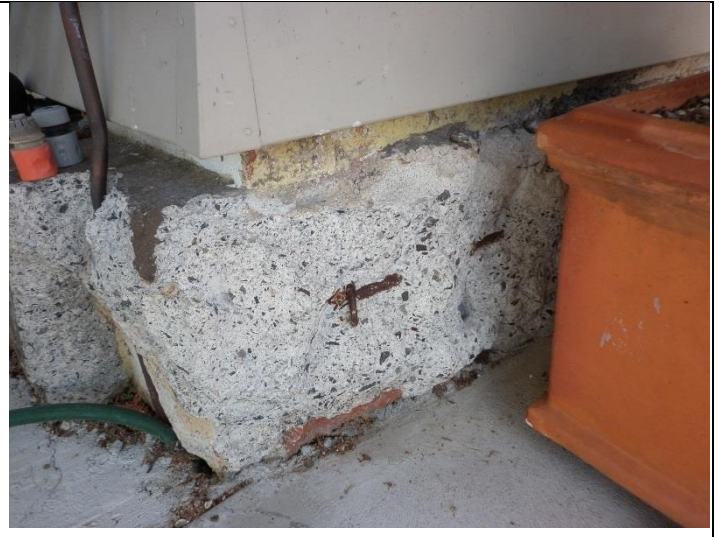
AREA	ITEM	A	B	C	D	R	UR	COMMENTS
SUBFLOOR	Ground Condition		✓					Dry underfloor.
	Ventilation		✓					Vents as required.
	Piles		✓					Concrete piles.
	Joists		✓					Rimu joists to older part of house. Pine joists to alteration.
	Foundation Walls		✓					Concrete filled block walls to garage basement.
	Insulation					✓		Third bedroom has underfloor insulation only.
	Footings						✓	Exposed reinforcing in footing needs plastering.

Exposed reinforcing in footing .Suggested plastering over footing to make good and keep steel from further rust.

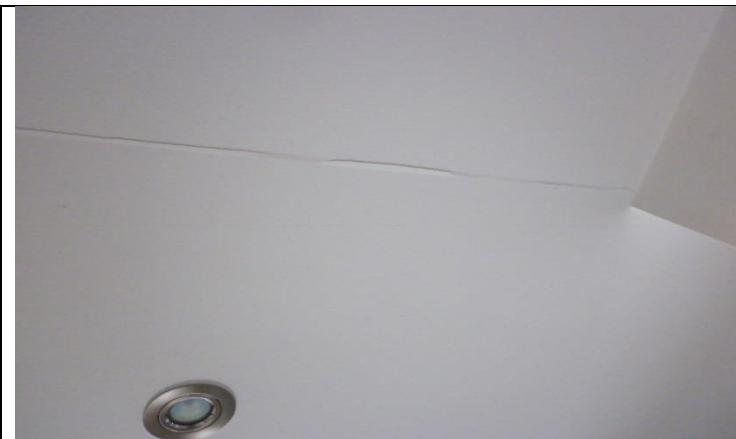
AREA	ITEM	A	B	C	D	R	UR	COMMENTS
HALL WAY	Doors		✓					
	Walls			✓				Paintwork in hallway has been damaged on left hand side.
	Ceiling				✓			Cracks in the hall ceiling need attention.
	Floor Coverings		✓					
	Cupboard Doors		✓					
	Windows		✓					
<p>Comments: Paintwork damage. Cracking in hall ceiling is possibly due to the long expanse of ceiling without any construction joints .This can be rectified by creating one where the crack has appeared.</p>

Crack in hall ceiling possibly due to it being a long hallway with no construction joint in the plasterboard. Suggest putting a construction joint in to stop future cracking.

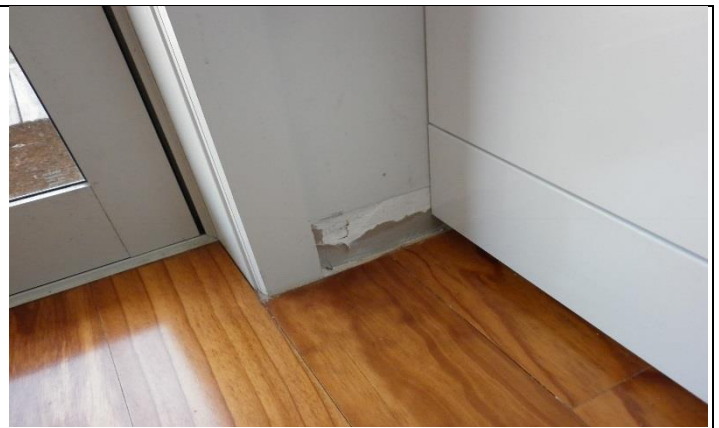
AREA	ITEM	A	B	C	D	R	UR	COMMENTS
LAUNDRY	Doors		✓					
	Walls					✓		Skirting board missing beside tub.
	Ceiling			✓				
	Tub	✓						
	Tapware	✓						
	Floor		✓					
Comments:

Skirting board missing in laundry.

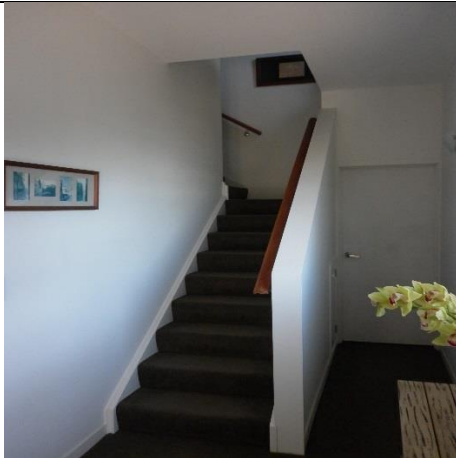
AREA	ITEM	A	B	C	D	R	UR	COMMENTS
STAIRS	Doors		✓					
	Walls		✓					
	Ceiling			✓				
	Floor Coverings			✓				
	Windows		✓					
	Hand Rails						✓	Hand rails need to be tightened.

Stairs hand rail need to be repaired and fixings tightened or replaced.
